FINAL REMEDIAL ACTION REPORT

**Cornell-Dubilier Electronics, Inc. Superfund Site
Operable Unit 1 (OU1) – Indoor Dust Remediation
Delmore Avenue and Jackson Avenue
South Plainfield, Middlesex County, New Jersey**

March 2015

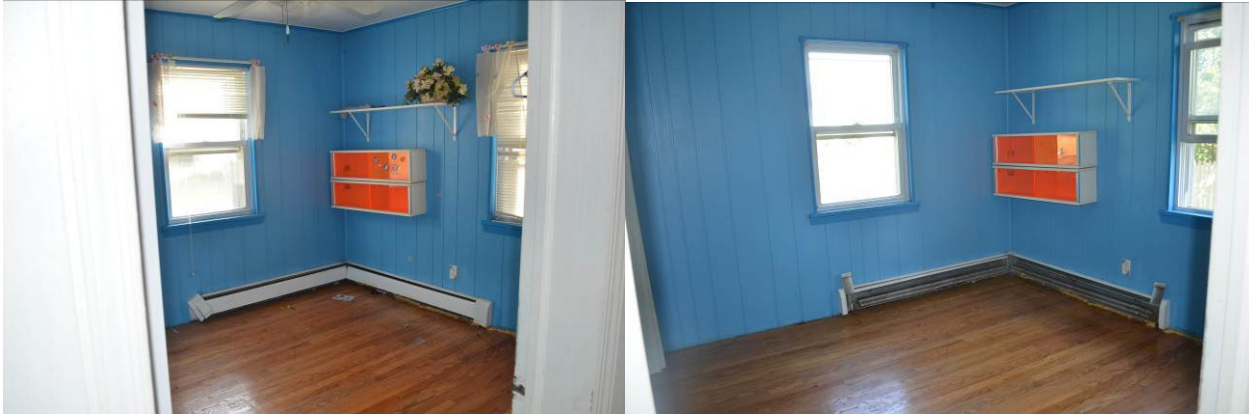
Photograph 1: Left photograph taken on August 4, 2014 prior to ERRS initiating the remediation of Property ID 307. The right photograph is post-cleaning taken on August 5, 2014. Heating baseboards were thoroughly washed and dusted. The closet items and window blinds were disposed of.

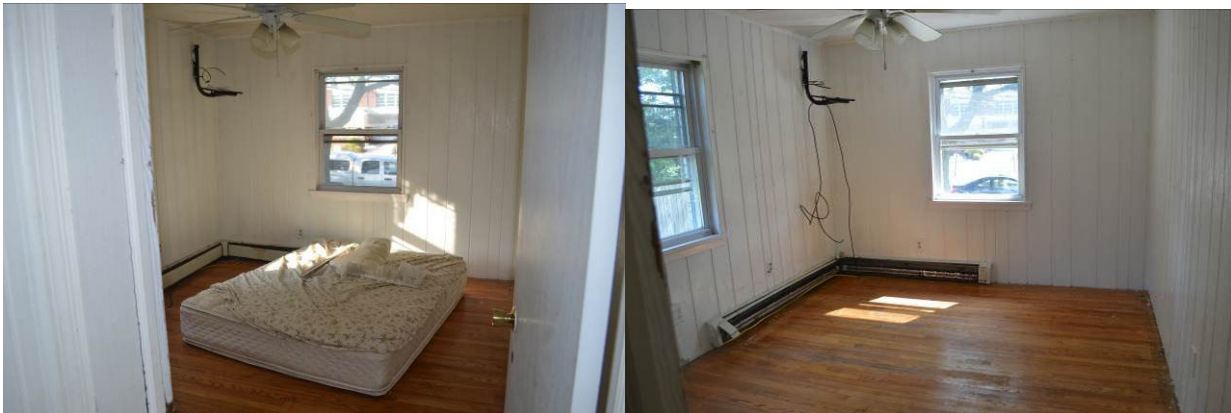
Photograph 2: Left photograph is a bedroom in Property ID 307 prior to cleaning. Photograph on the right is post-cleaning. The mattress and items in closet were disposed of and baseboard vents were thoroughly cleaned.

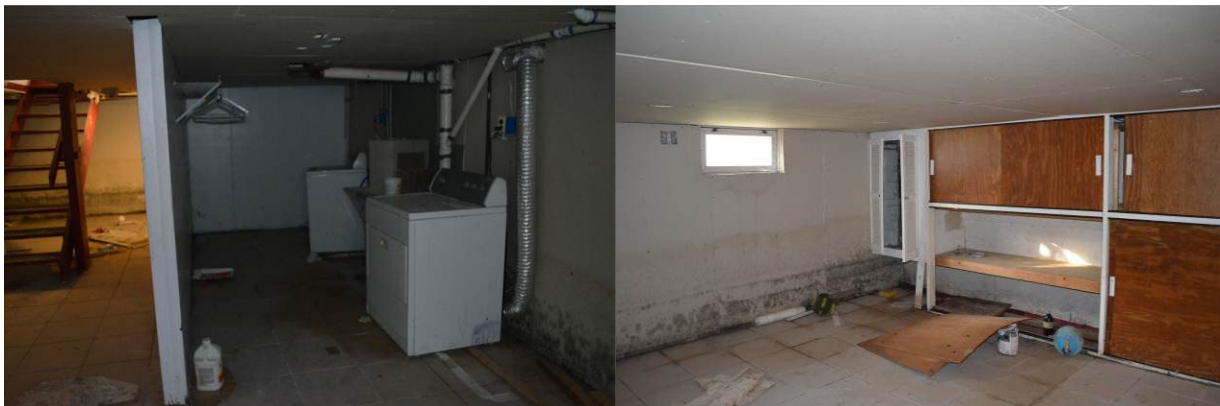
Photograph 3: Left photograph was taken facing the north and the right photograph was taken facing the south within the basement of Property ID 307. Both photographs were taken on August 4, 2014, prior to cleaning.

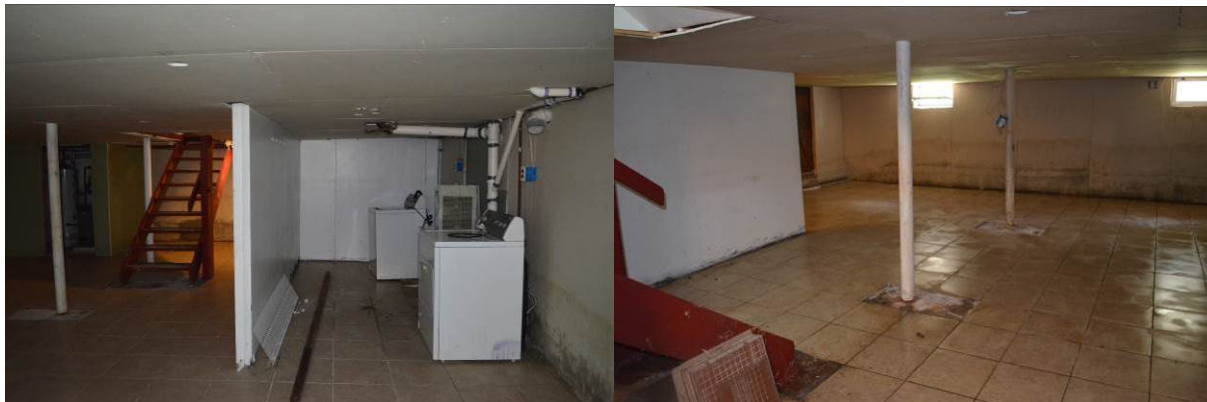
Photograph 4: Photographs of the ERRS completed cleaning of the basement within Property ID 307 on August 5, 2014. Ceiling, walls, floor, and appliances were HEPA vacuumed and wiped with Lestoil and water.

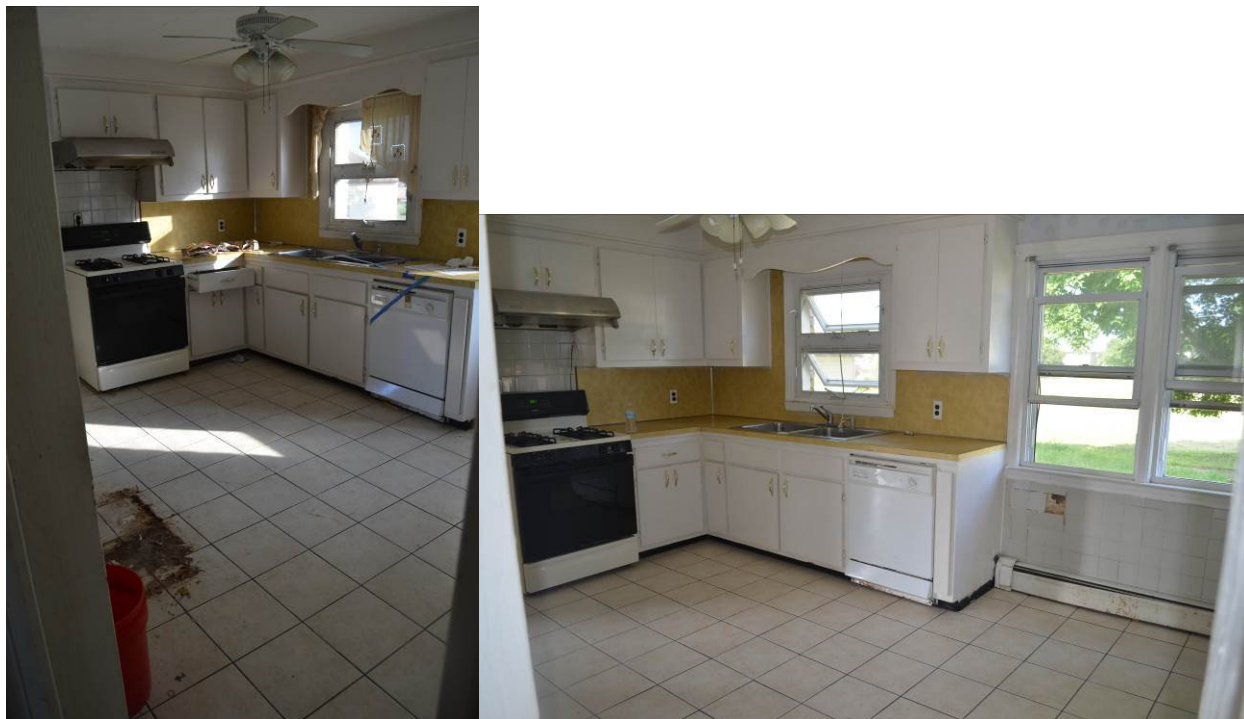
Photograph 6: Left photograph is the pre-cleaned kitchen of Property ID 307 photographed on August 4, 2014. Right photograph is the remediated kitchen.

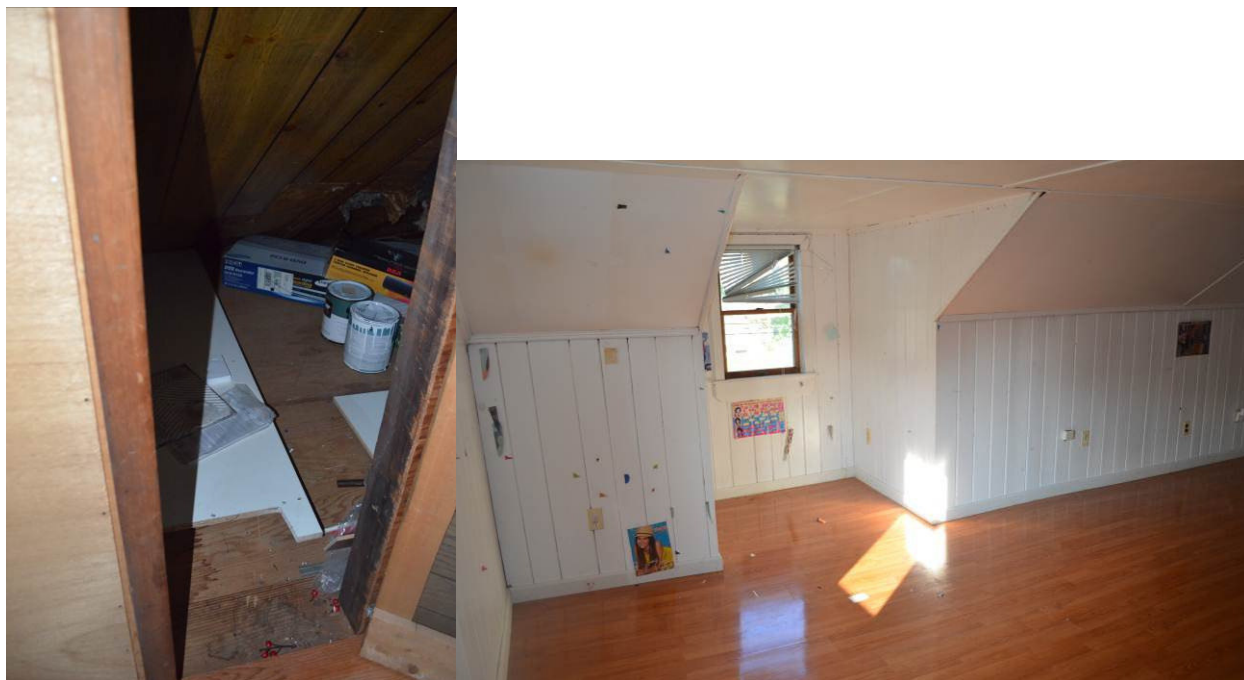
Photograph 7: ERRS removed and disposed of furniture, paints and items in second floor closet of Property ID 307 and vacuumed and washed the ceiling, walls, vents and floor.

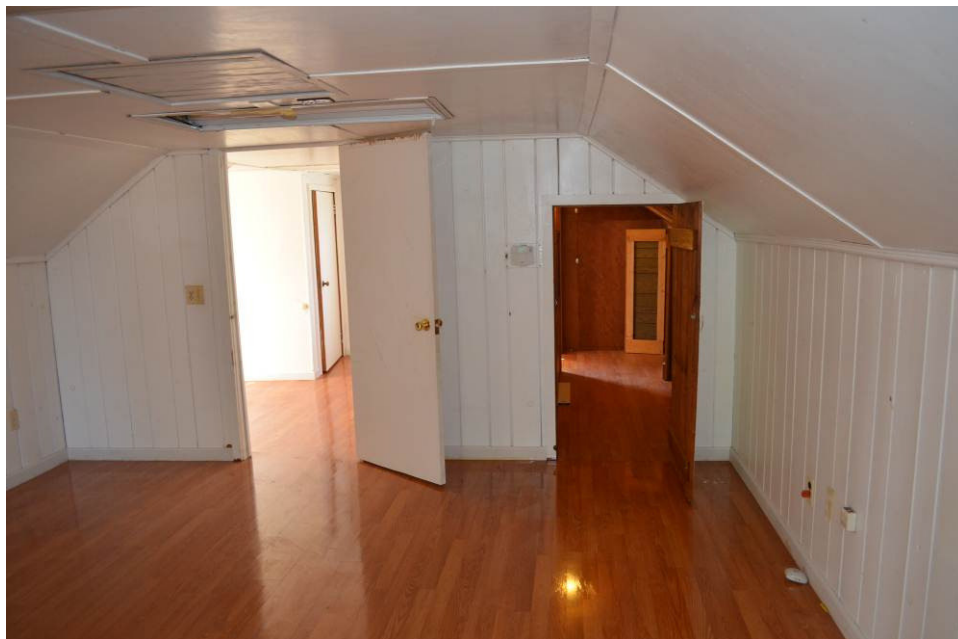
Photograph 8: Photograph taken on August 5, 2014 of the post-cleaned sencond floor of Property ID 307.

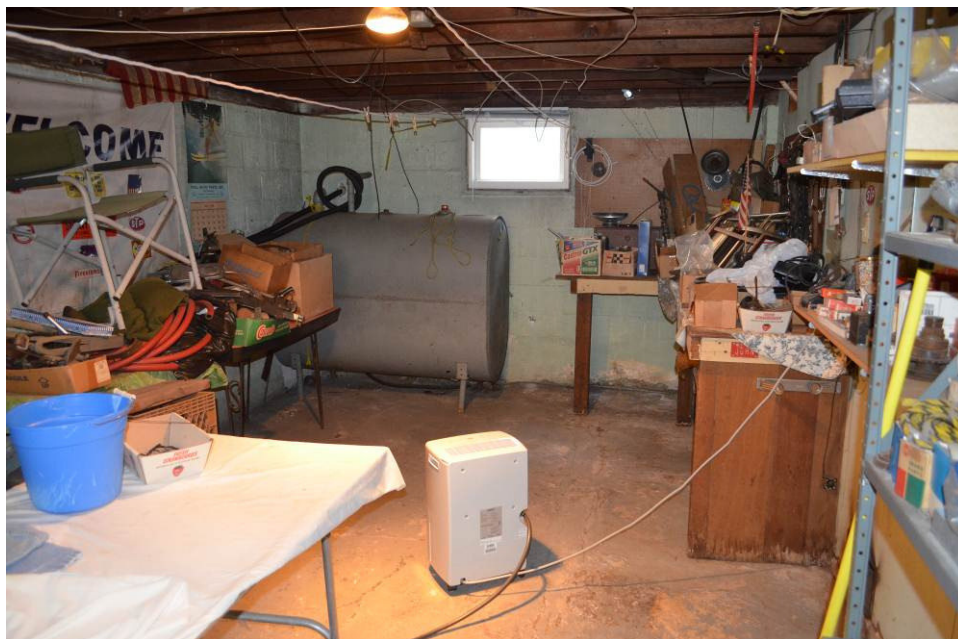
Photograph 9: Photograph taken on August 6, 2014 prior to cleaning of Property ID 129. ERRS HEPA vacuumed and wiped the basement ceiling, walls, floor, and items with Lestoil and water.

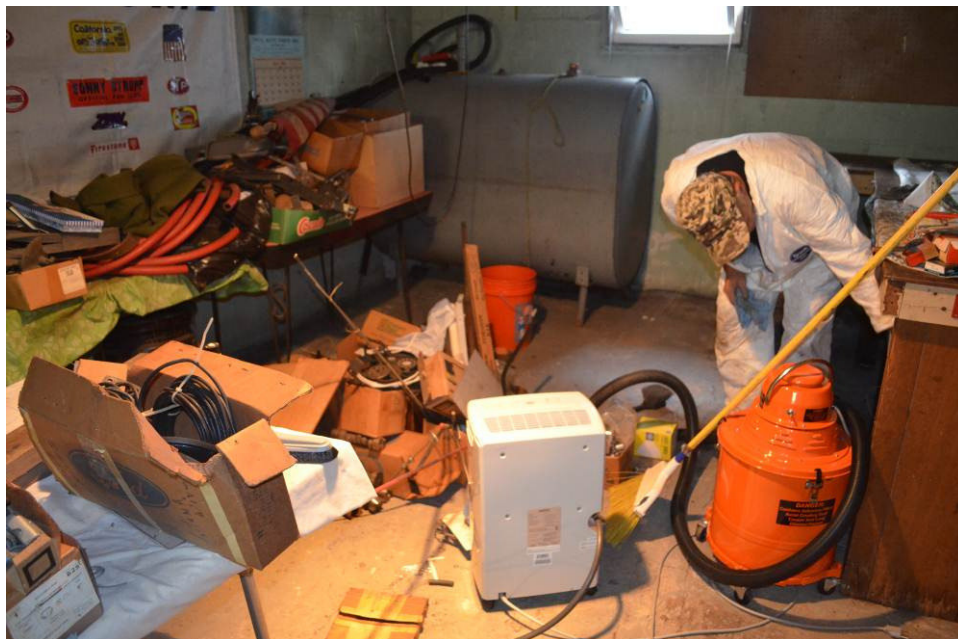
Photograph 10: ERRS performing cleaning activities in the basement of Property ID 129. Each item was wiped and neatly placed back into its respective spot after cleaning.

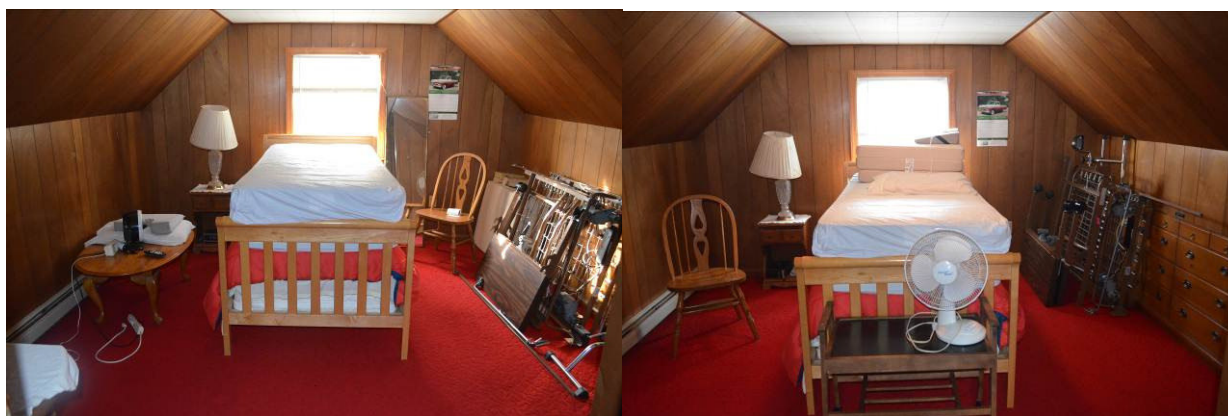
Photograph 11: Left photograph taken on August 6, 2014 before cleaning of the bedroom at Property ID 129 and right photograph after cleaning on August 8, 2014.

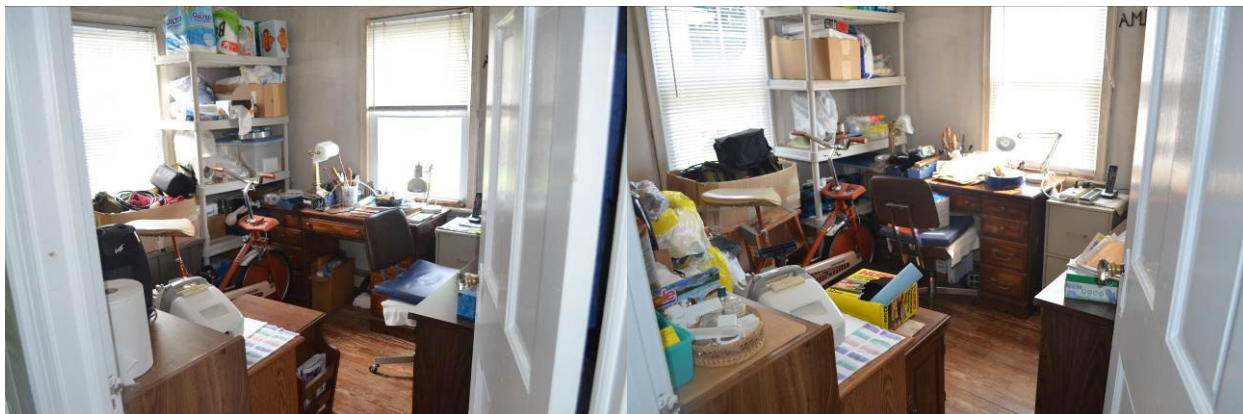
Photograph 12: Left photograph taken on August 6, 2014 before cleaning and right photograph taken on August 8, 2014 after cleaning at Property ID 129.
